Dryer Shuts Down – Computer Screen Doesn't Have An Error Message Igniter Electrode Adjustment

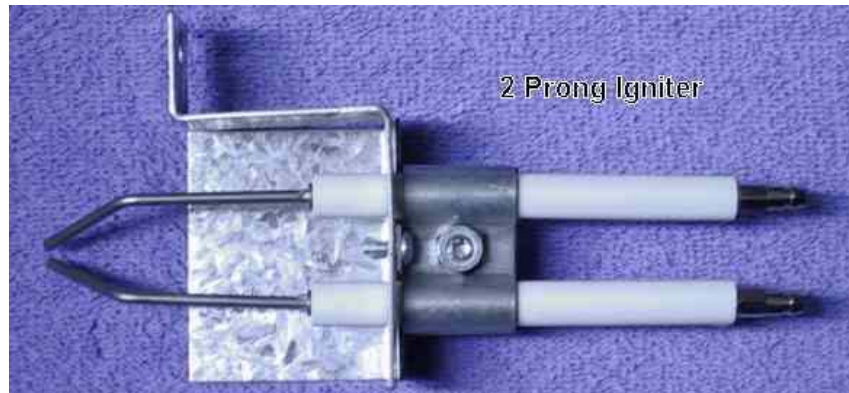
- The igniter electrodes must be adjusted for a maximum gap of 1/8" between the prong ends.
- Too wide a gap between the igniter electrodes can cause "noise" during ignition. Too much "noise" interference can cause the computer to "reboot". When the computer "reboots" the dryer shuts down but no error message gets posted to the computer screen.
- Igniters should be positioned so that they do not touch any metal around them.

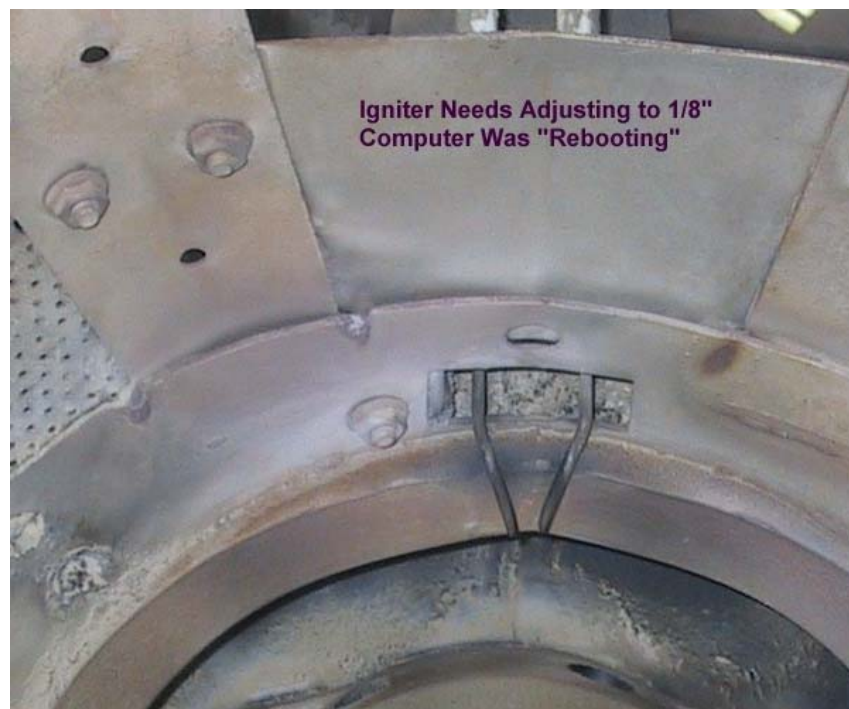
Note: The illustrations of a properly adjusted igniter assembly as well as a photo of an igniter in a dryer that requires adjustment.
